# EFFECT OF CREVICE CONFIGURATION ON CORROSION BEHAVIOUR OF TENSILE WIRES OF FLEXIBLE PIPES UNDER DIFFERENT CONDITIONS

Laboratório de Corrosão  
COPPE|UFRJ  
DMM ▪ PEMM ▪ Poli

Érica Vidaurre Senatore, D.Sc  
Pedro Netto da Silva, M.Sc  
Professor José Antônio da Cunha Ponciano Gomes

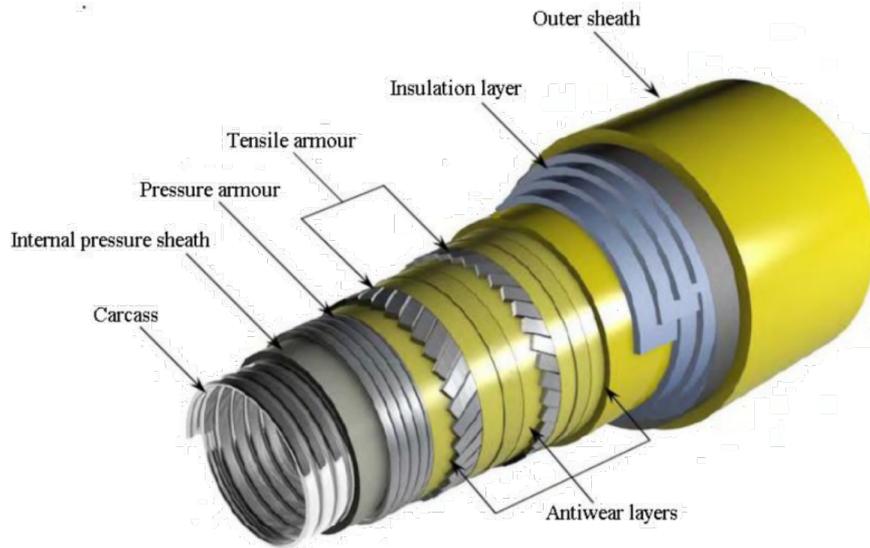
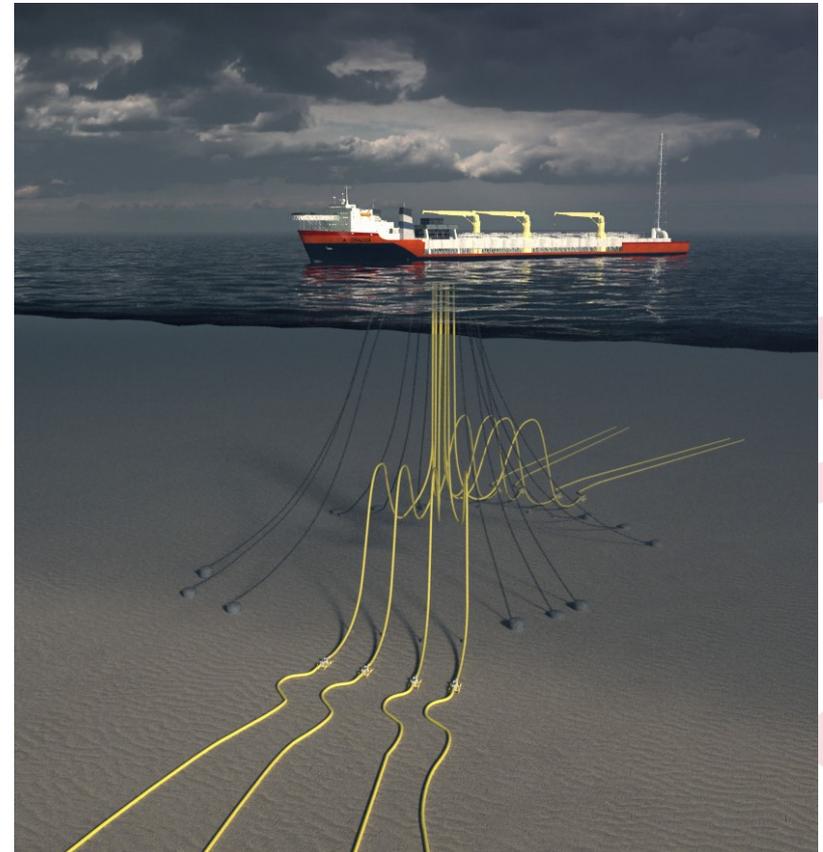
- ❑ Schematic indicating the multi-layer construction of flexible pipe designs

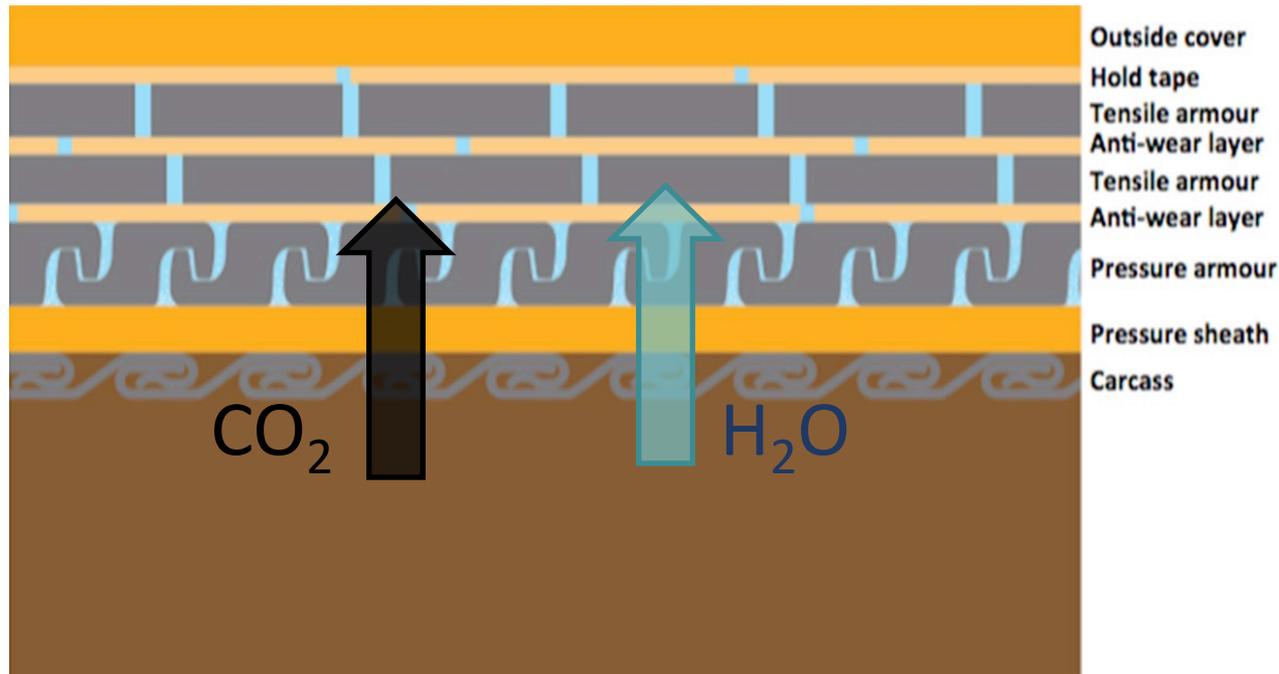
- The high strength steel wires are confined in the annulus and in contact with a corrosive environment formed by gases and water molecules diffusing from the bore through the inner polymer layers.

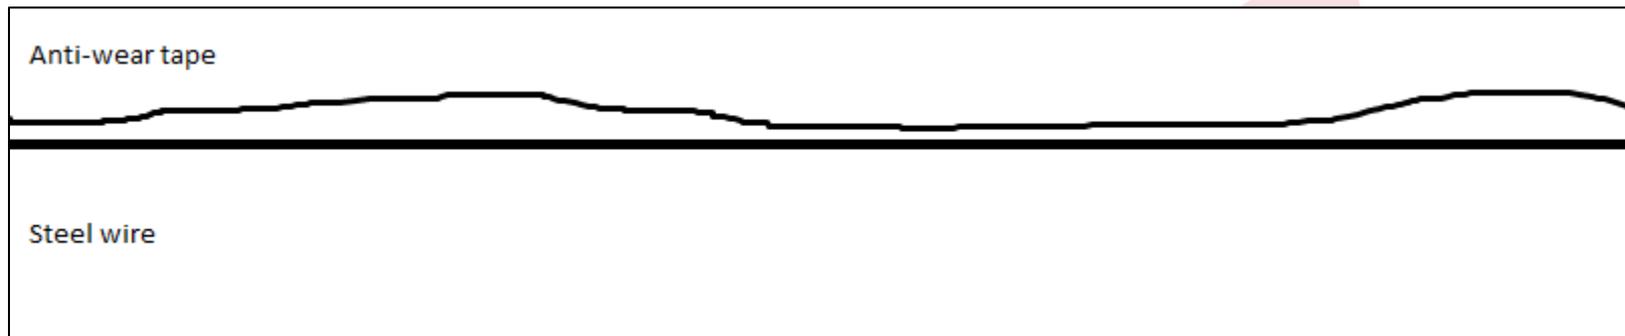
- ❑ The tensile wires are usually covered by antiwear tapes and this configuration can also interfere in their corrosion behaviour.
- ❑ The position of the tape relative to the wire is not uniform due to many variations in the manufacturing process of the pipe.
- ❑ **Some regions** → almost **absolute intimate contact**.  
**Other region** → there is a **gap** between the polymer and the steel → **allowing water and gases** to reach the **surface of the wire**.

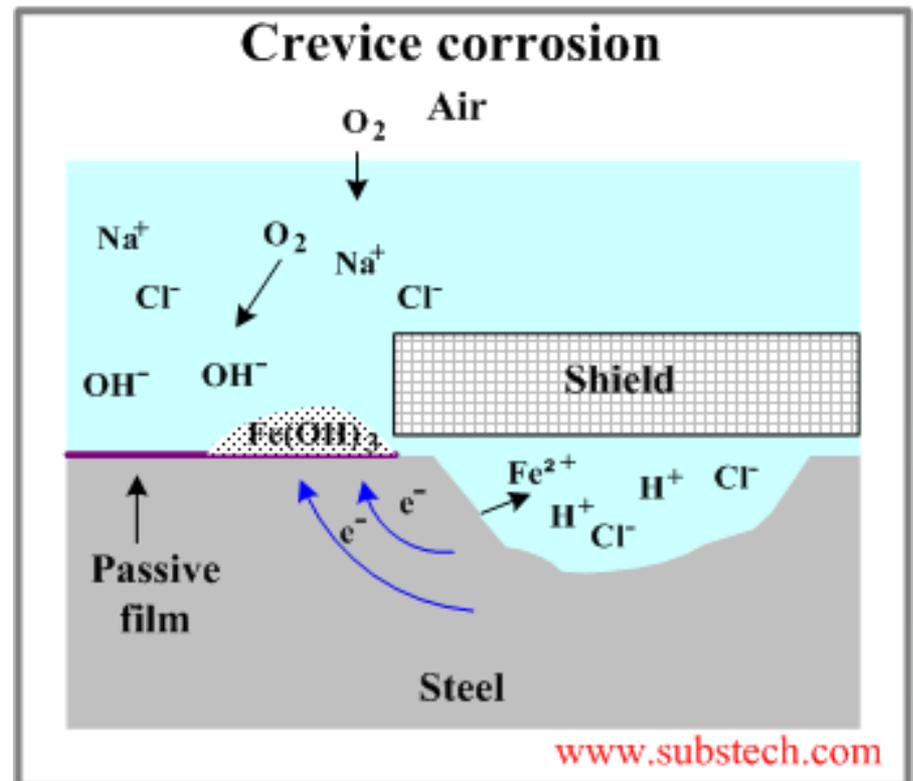
- ❑ If this gap is wide enough to guarantee sufficient mass transport of chemical species, the composition of the fluid in the annulus in this region will be relatively homogeneous.
- ❑ If this gap is so narrow that locally the chemistry of the corrosive environment develops differently than in the bulk, localised corrosion may occur.

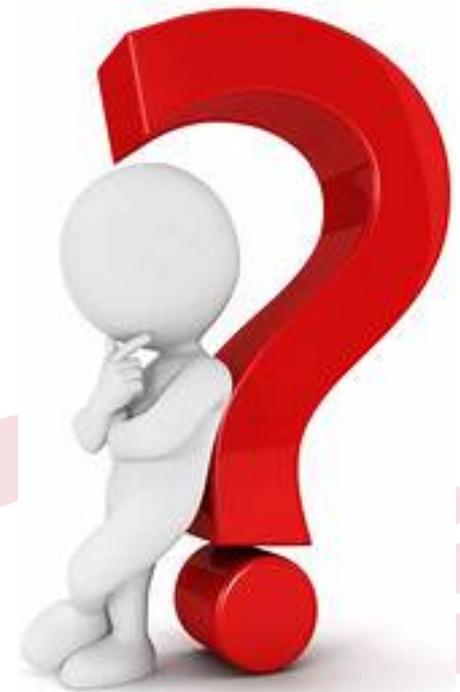
Uniform corrosion → where the **opening is large** enough to **allow mass transport** and **prevent the development of a different local environments**

Localised corrosion → where the **opening is so narrow** that the environment **develops differently in these regions.**

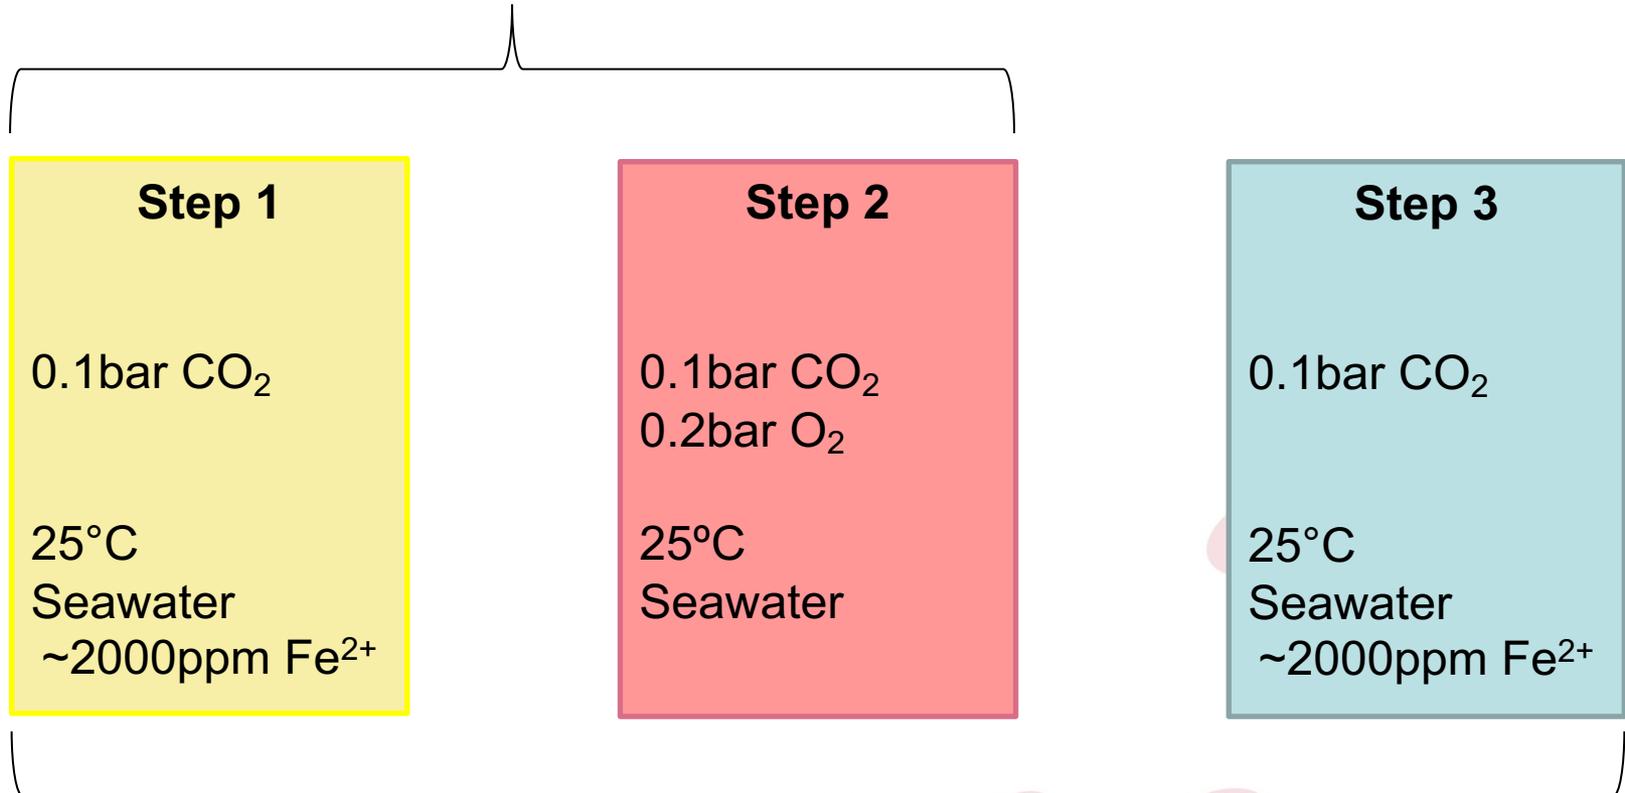
Test 1: 30 days – Finished

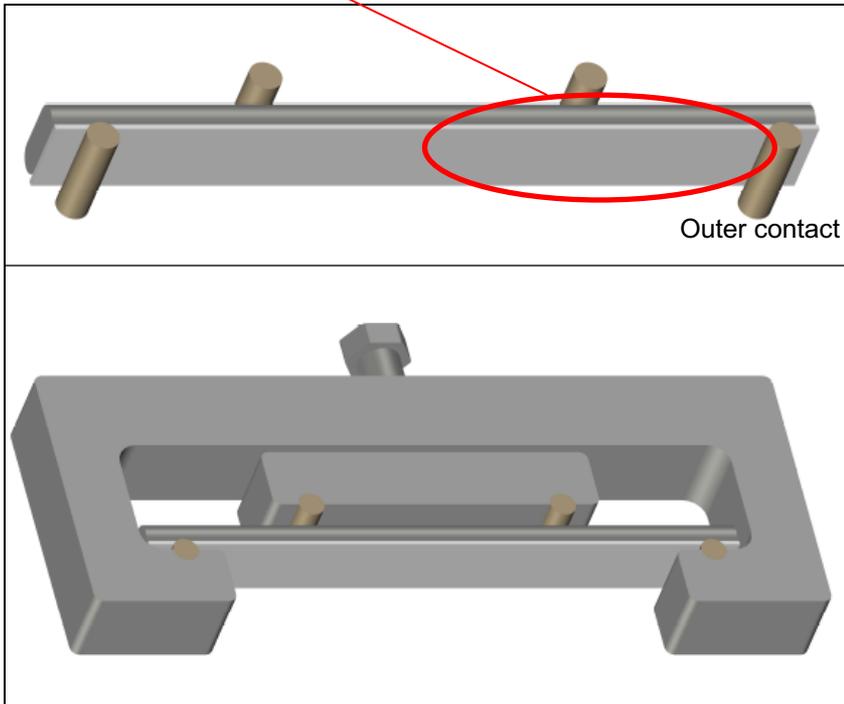
TEFLON: Low friction coefficient →  
 sliding during the deformation  
 process → difficult a uniform contact

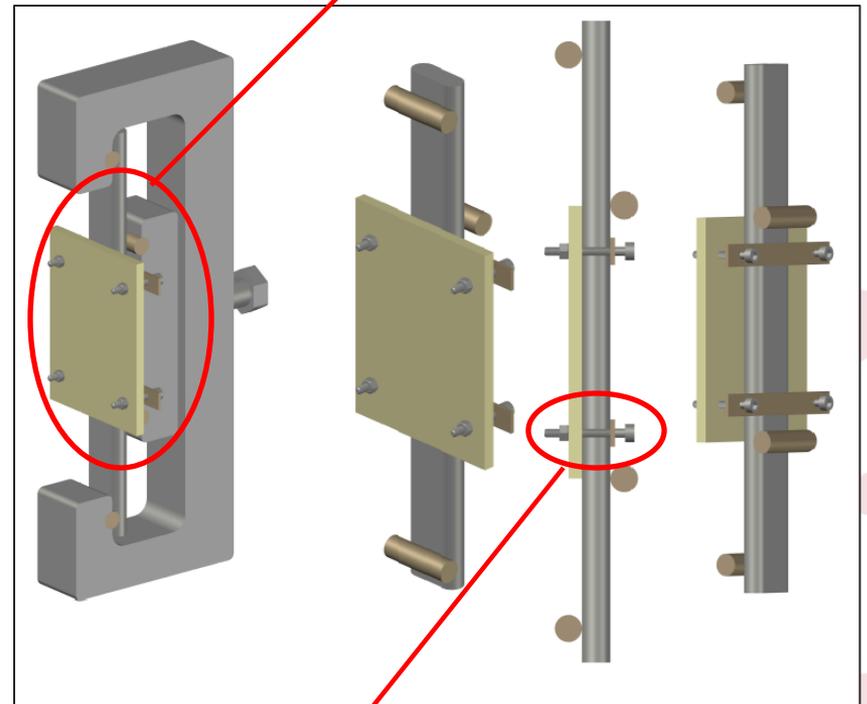
PA11: Higher friction  
 coefficient. Covering only the  
 region A (central portion of

Nuts and bolts to facilitate the adjust the gap  
 between polymer and specimen before loaded

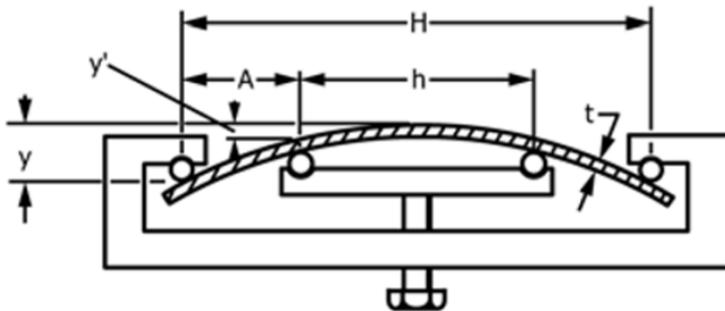
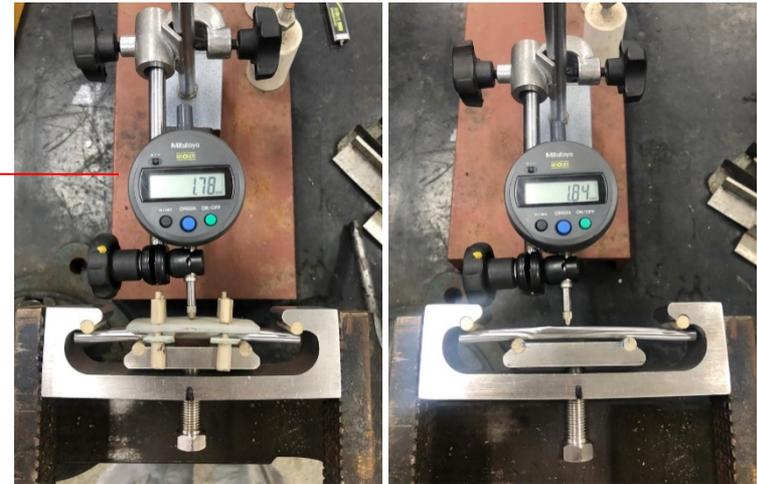
Test specimens were loaded to 90% YS.  
Creviced specimens had their deflection measured already with the polymer tape.

Dial indicator

$$\sigma = \frac{12 \cdot E \cdot t \cdot y}{(3 \cdot H^2 - 4 \cdot A^2)} \quad \therefore \quad y = \frac{\sigma \cdot (3 \cdot H^2 - 4 \cdot A^2)}{12 \cdot E \cdot t}$$

y	deflection
$\sigma$	stress on the outer fiber (convex surface)
H	distance between outer supports
A	distance between inner support and closest outer support
E	Young's modulus (usually E=210GPa for steels)
t	specimen thickness

INPUT			OUTPUT	
%Y.S.	Y.S.		$\sigma$	
(MPa)	(MPa)		(MPa)	
90	1085		976.5	
INPUT			OUTPUT	
H	A	E	t	y
(mm)	(mm)	(GPa)	(mm)	(mm)
100	23	210	5.88	1.84

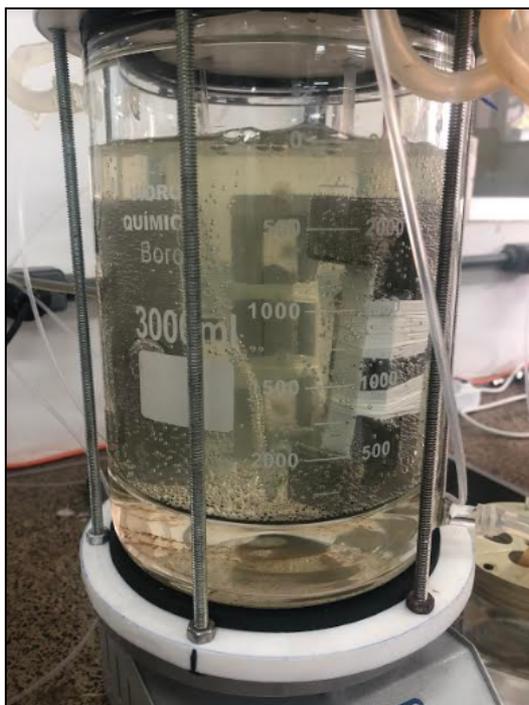
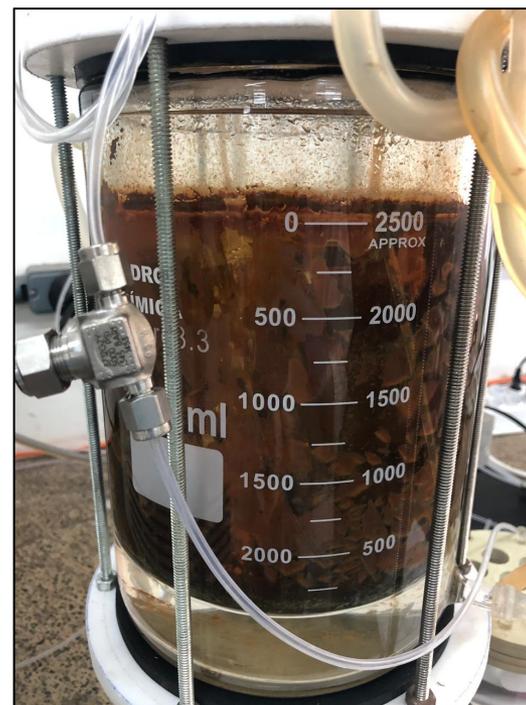
Test cell aspects according to the variations of the test environment.

**Step 1**

**Step 2**

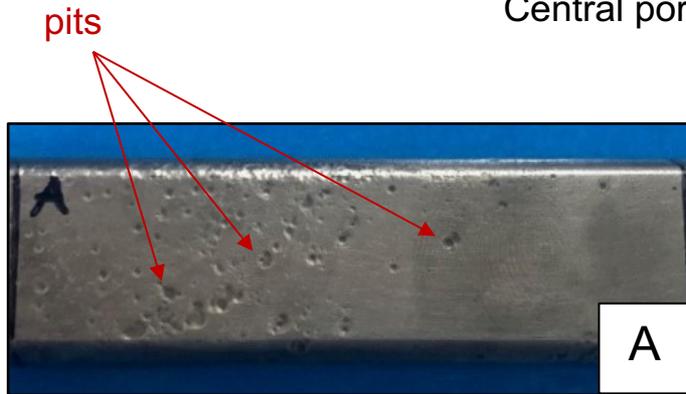
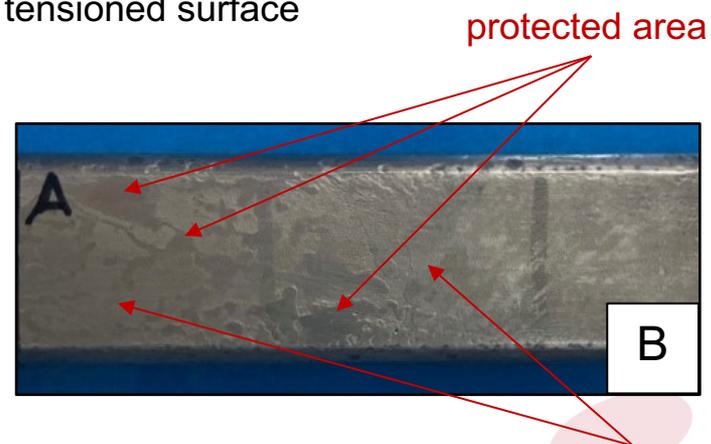
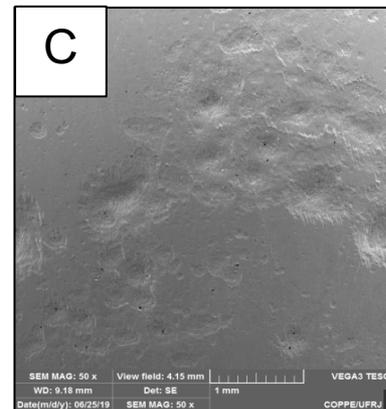
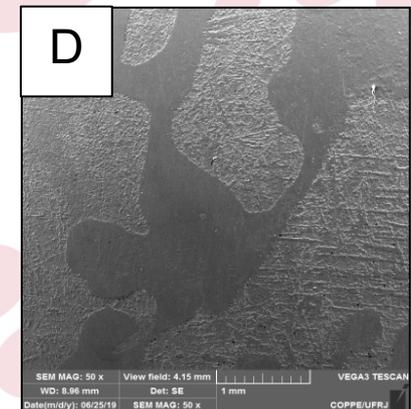
Central portion of the tensioned surface

Macroscopic analysis: (A) Bare specimen  
(B) creviced specimen

SEM analysis: (C) Pitted area: Bare specimen  
(D) Protected regions and uniform corrosion: creviced specimen

- No cracks were observed.
  - Pitting was observed in the specimen tested without crevice.
  - The polymer tape on the surface of the steel prevented pitting.
  - Severe uniform corrosion was observed under the polymer tape.
-

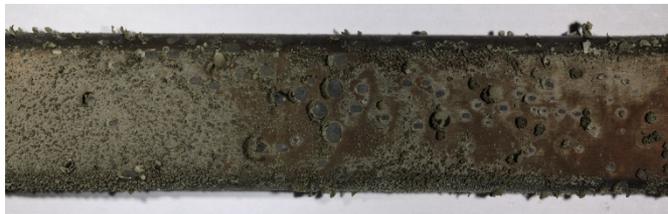
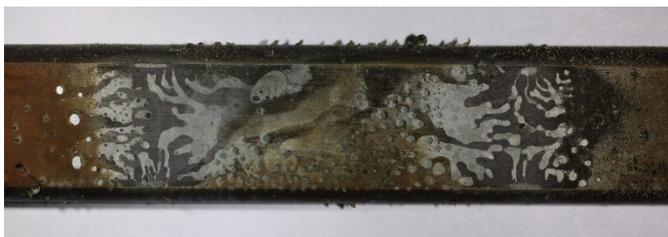
**Before cleaning**

Bare specimen

Creviced specimen

**No pitting – iron carbonate film**

Localised attacks resulted from CO<sub>2</sub> bubbles retained at the surface of the bare specimen.

- No cracks were observed.
- No pitting was observed in the specimen tested without crevice.
- Localised attacks resulted from CO<sub>2</sub> bubbles retained at the surface of the bare specimen. As they were large and shallow, did not characterise pitting.
- The bare specimens were relatively protected by the iron carbonate film and almost did not corrode.
- Uniform corrosion was observed under the polymer tape, although not as severe as in the specimens exposed to oxygen.

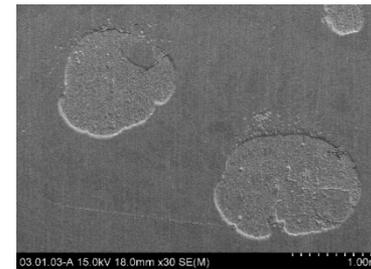
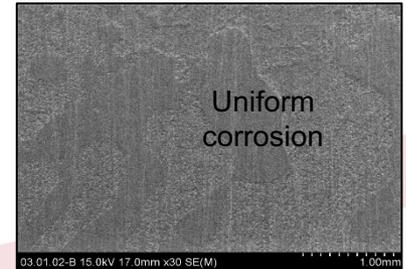
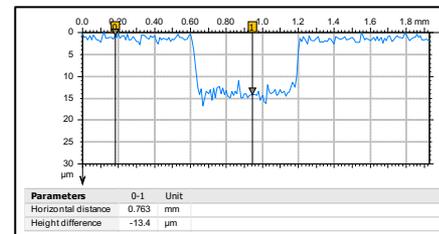
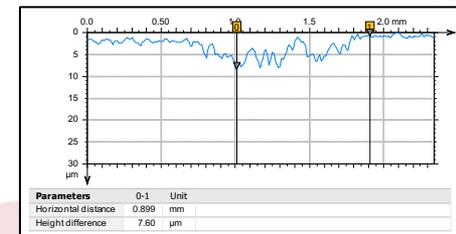
Bare specimen

Uniform corrosion

Creviced specimen

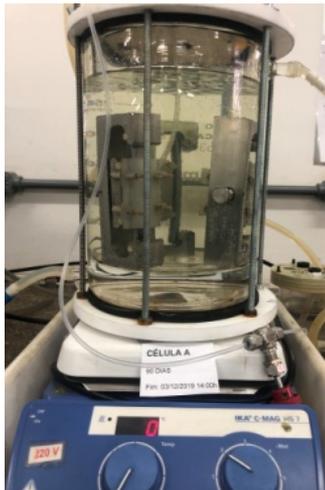
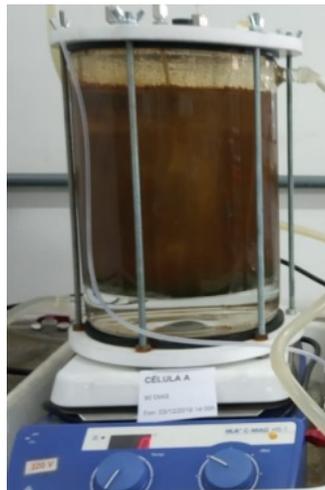
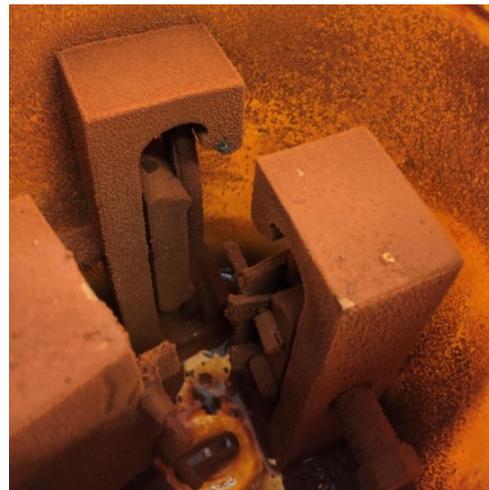
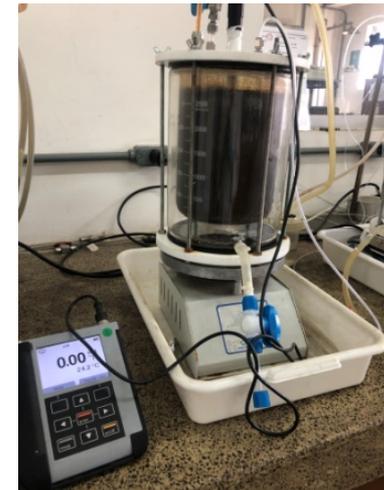
Test cell aspects according to the variations of the test environment.

A: first day of experiment, **with only CO<sub>2</sub> and N<sub>2</sub> in the gas mixture. Before heavy precipitation of iron carbonate.**

B: gas mixture is changed and **oxygen reacts to the dissolved iron and disrupts the iron carbonate films.**

C: test cell after the test solution was drained at the **end of step 2, and before step 3 started.**

D: test cell **during step 3.**
